Quarterly Technical  
Newsletter of Australia's  
leading supplier of  
low-voltage motor control  
and switchgear.

## CONTACTOR FAILURE

### Reasons for contactor failure

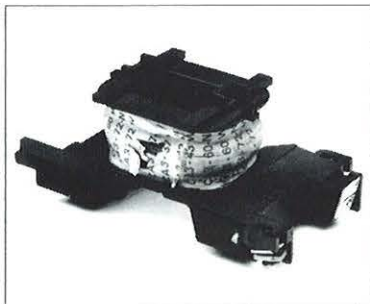
### Coil windings

**Fig. 2.**  
*Contactor coil with burnt out winding*

The actual construction of the coil is very important, as this determines the maximum voltage between turns. The position of the lead to the start of winding is usually the problem area. If this lead is allowed to come into contact with the top windings, maximum voltage stress is produced. A failure between turns first results in a shorted turn, or turns, which behaves like a short on a transformer. The current in the affected turns increases, and a burnt ring appears on the coil. The wire will eventually fuse and the coil becomes open circuit.

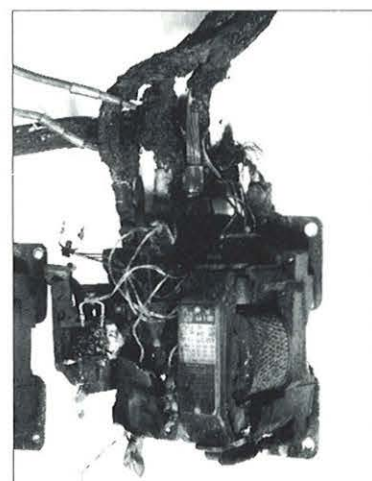
The compact design of the modern contactor means the phase separation is small. Flashover between phases does occur, but usually these can be traced to connection problems. A loose connection can produce an arc which can quickly transfer into a phase to phase fault. The resulting current can also cause internal damage to the contactor.

Internal flashovers are rare, but should never be found on a contactor operating within its design limits. Failure to

**Fig. 4.**  
*Flashovers can be very  
destructive*
